LOCATION MAP AND TABLE OF

FIRST FLOOR **BULK SAMPLE LOCATIONS AND ASBESTOS** CONTAINING **MATERIALS**

ASBESTOS PRE-DEMOLITION SURVEY FOR BEECH-NUT NUTRITION CORPORATION

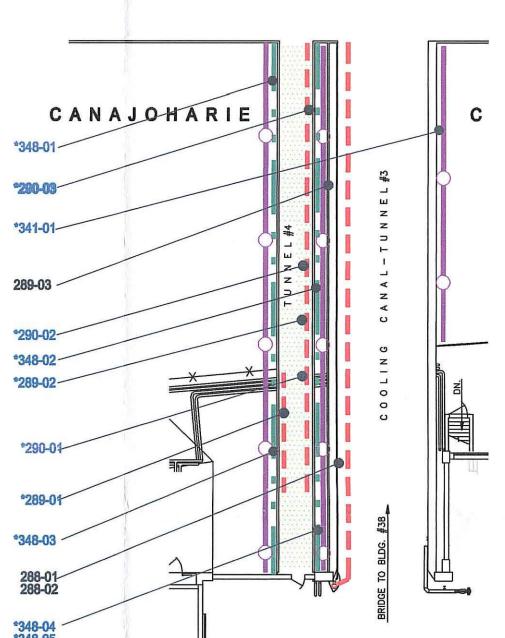
2 FIRST FLOOR TUNNELS #1 & 2 (SOUTH EAST)
SCALE: 1/16*=1*-0*

LEGEND - SEE 2/ASB101 (TUNNELS 1 & 2)	QTY.
XXXXX	SAMPLE NUMBER	N/A
•	SAMPLE LOCATION NUMBER	N/A
XXXXX	POSITIVE SAMPLE NUMBER	N/A
	THERMAL SYSTEM INSULATION LARGE AND SMALL DIAMETER	100 S.F.
0	PIPE FITTINGS	1 EACH
O	EXTERIOR GALBESTOS SIDING	5,000 S.F.

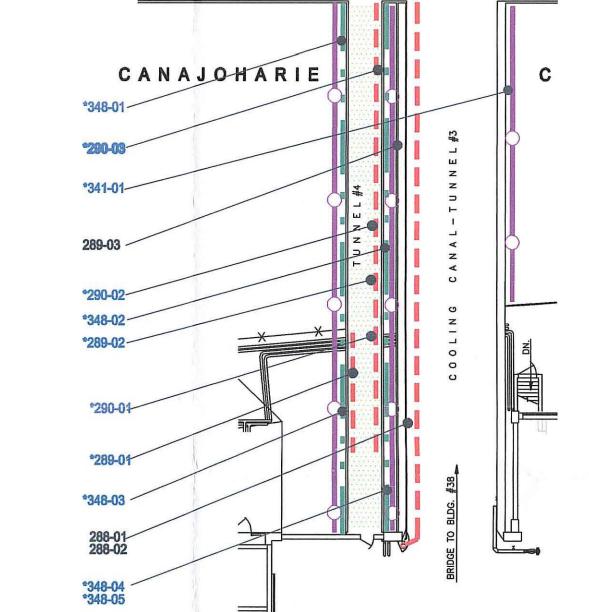
3 FIRST FLOOR TUNNELS #3 & 4 (NORTH EAST)
SCALE:1/16*=1'-0*

LEGEND - SEE 3/ASB101 (TUNNELS 3 & 4)	QTY.
XXXXX	SAMPLE NUMBER	N/A
0	SAMPLE LOCATION NUMBER	N/A
XXXXX	POSITIVE SAMPLE NUMBER	N/A
	THERMAL SYSTEM INSULATION LARGE AND SMALL DIAMETER	240 S.F
•	PIPE FITTINGS	40 EACH
	DEBRIS	1,000 S.F
	EXTERIOR GALBESTOS SIDING	3,750 S.F
EEO O D EEO	EXTERIOR WHITE PAINT	SEE NOTE

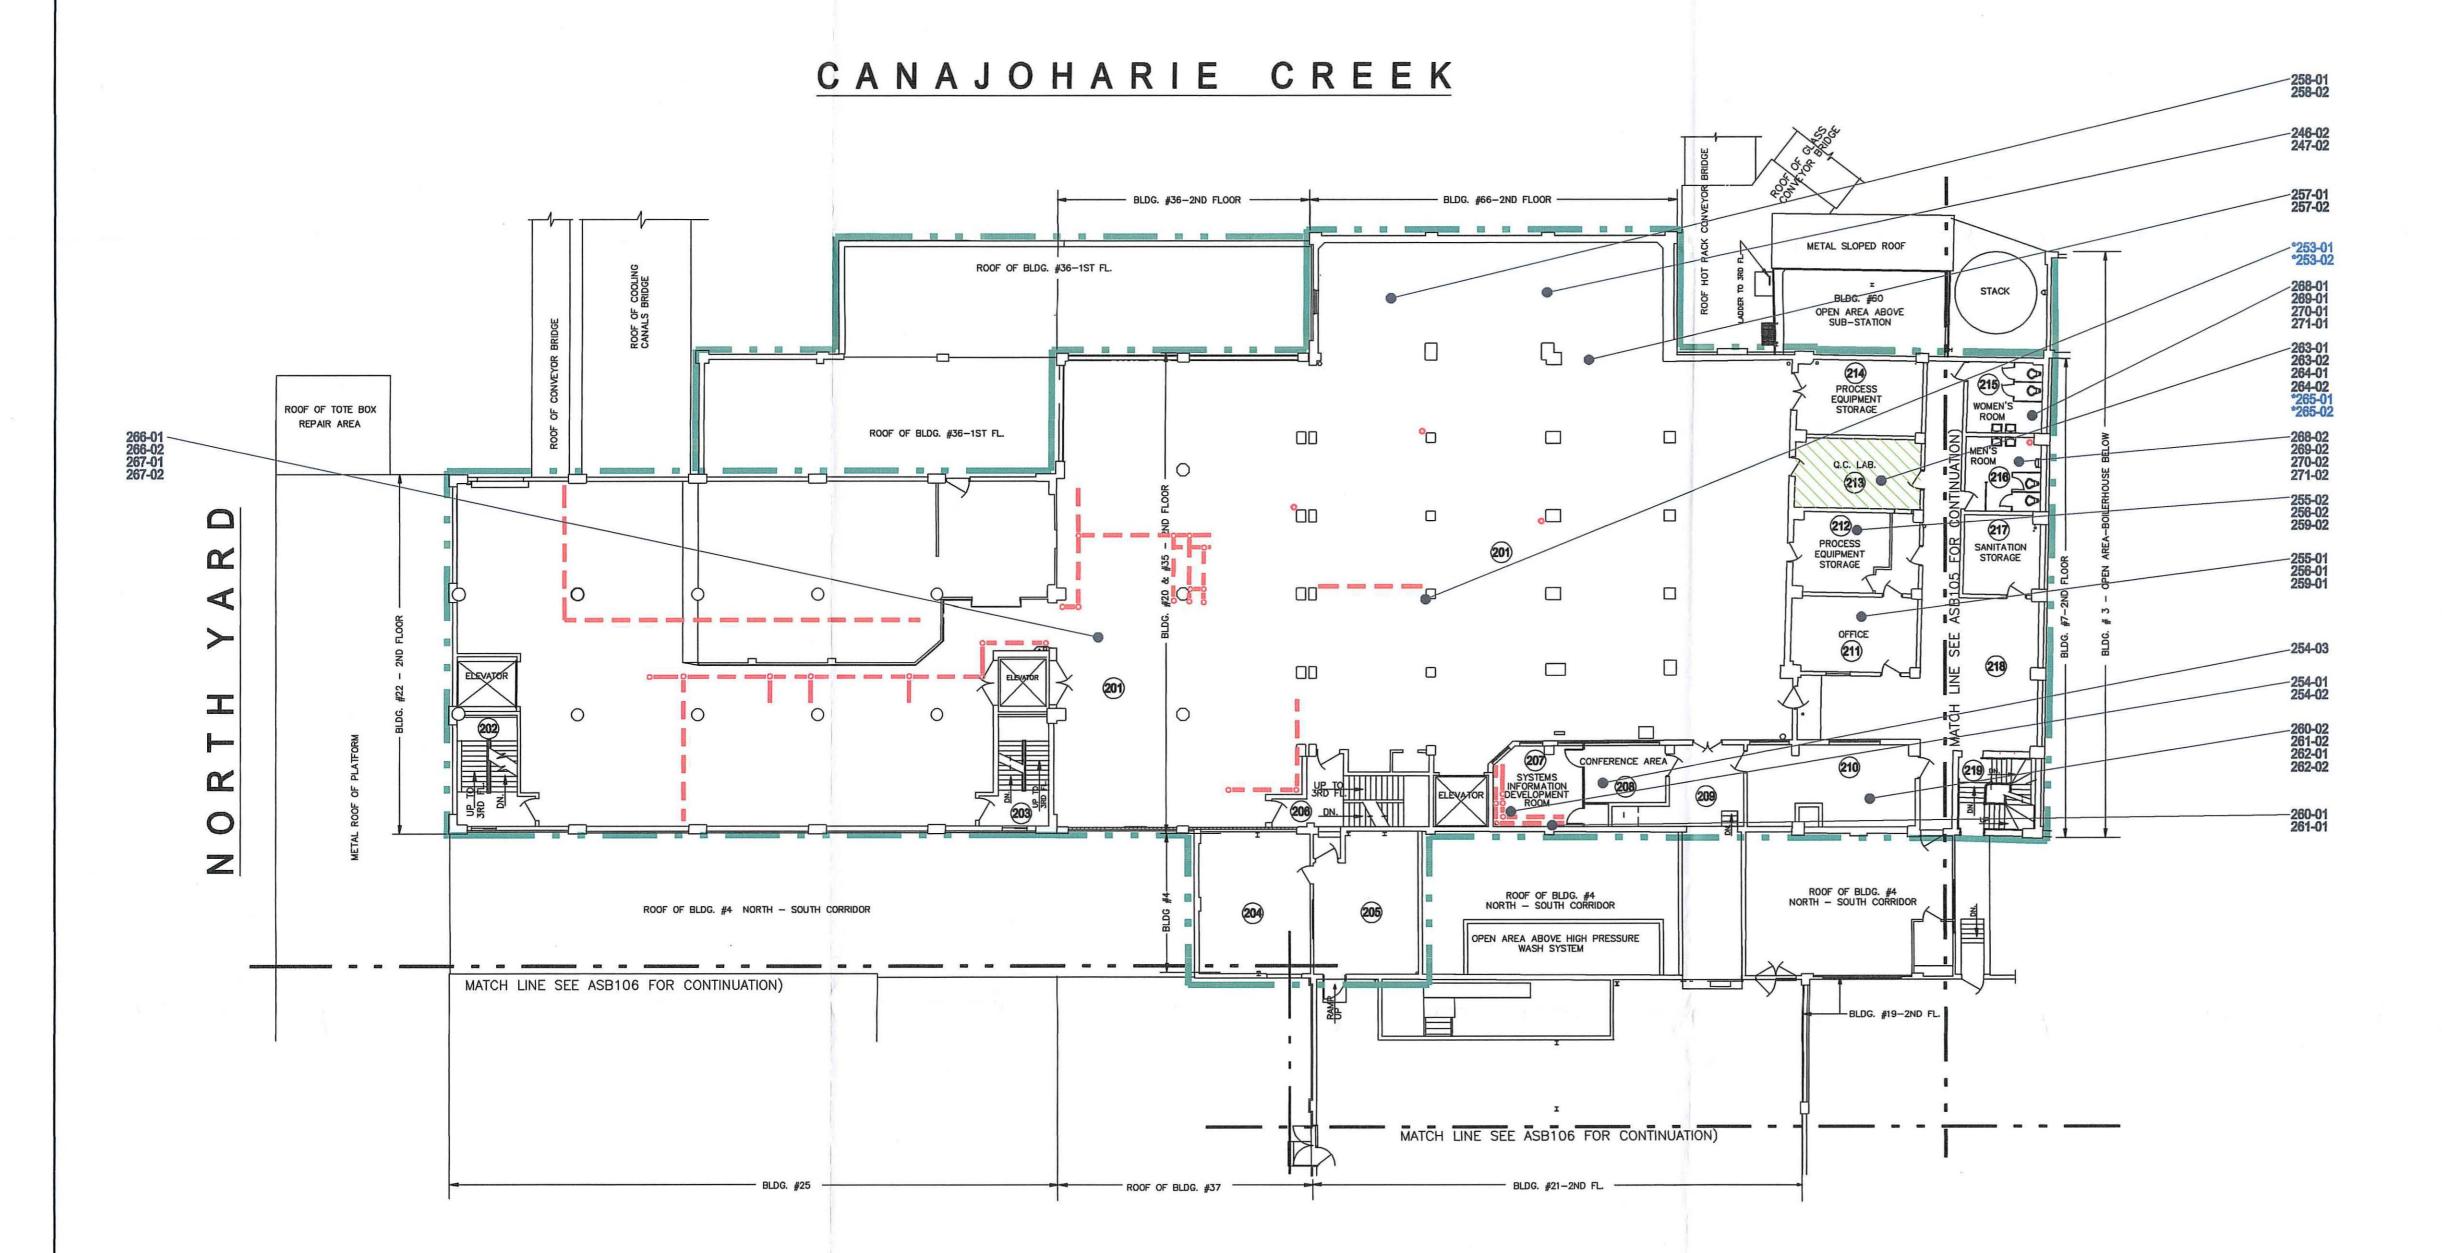
1 SECOND FLOOR - STRAINED FOOD BUILDING BUILDINGS - #4, #7, #20, #22, #35, #36, #60 AND #66

LEGEND	QTY.
XXXXX	SAMPLE NUMBER	N/A
0	SAMPLE LOCATION NUMBER	N/A
*XXXXXX	POSITIVE SAMPLE NUMBER	N/A
	EXTERIOR WHITE PAINT	SEE NOTE
	12x12 FLOOR TILE - GREEN, BROWN, WHITE,. RED, BLACK, TAN	300 S.F
	THERMAL SYSTEM INSULATION LARGE AND SMALL DIAMETER	450 L.F
0	PIPE FITTINGS	28 EACH

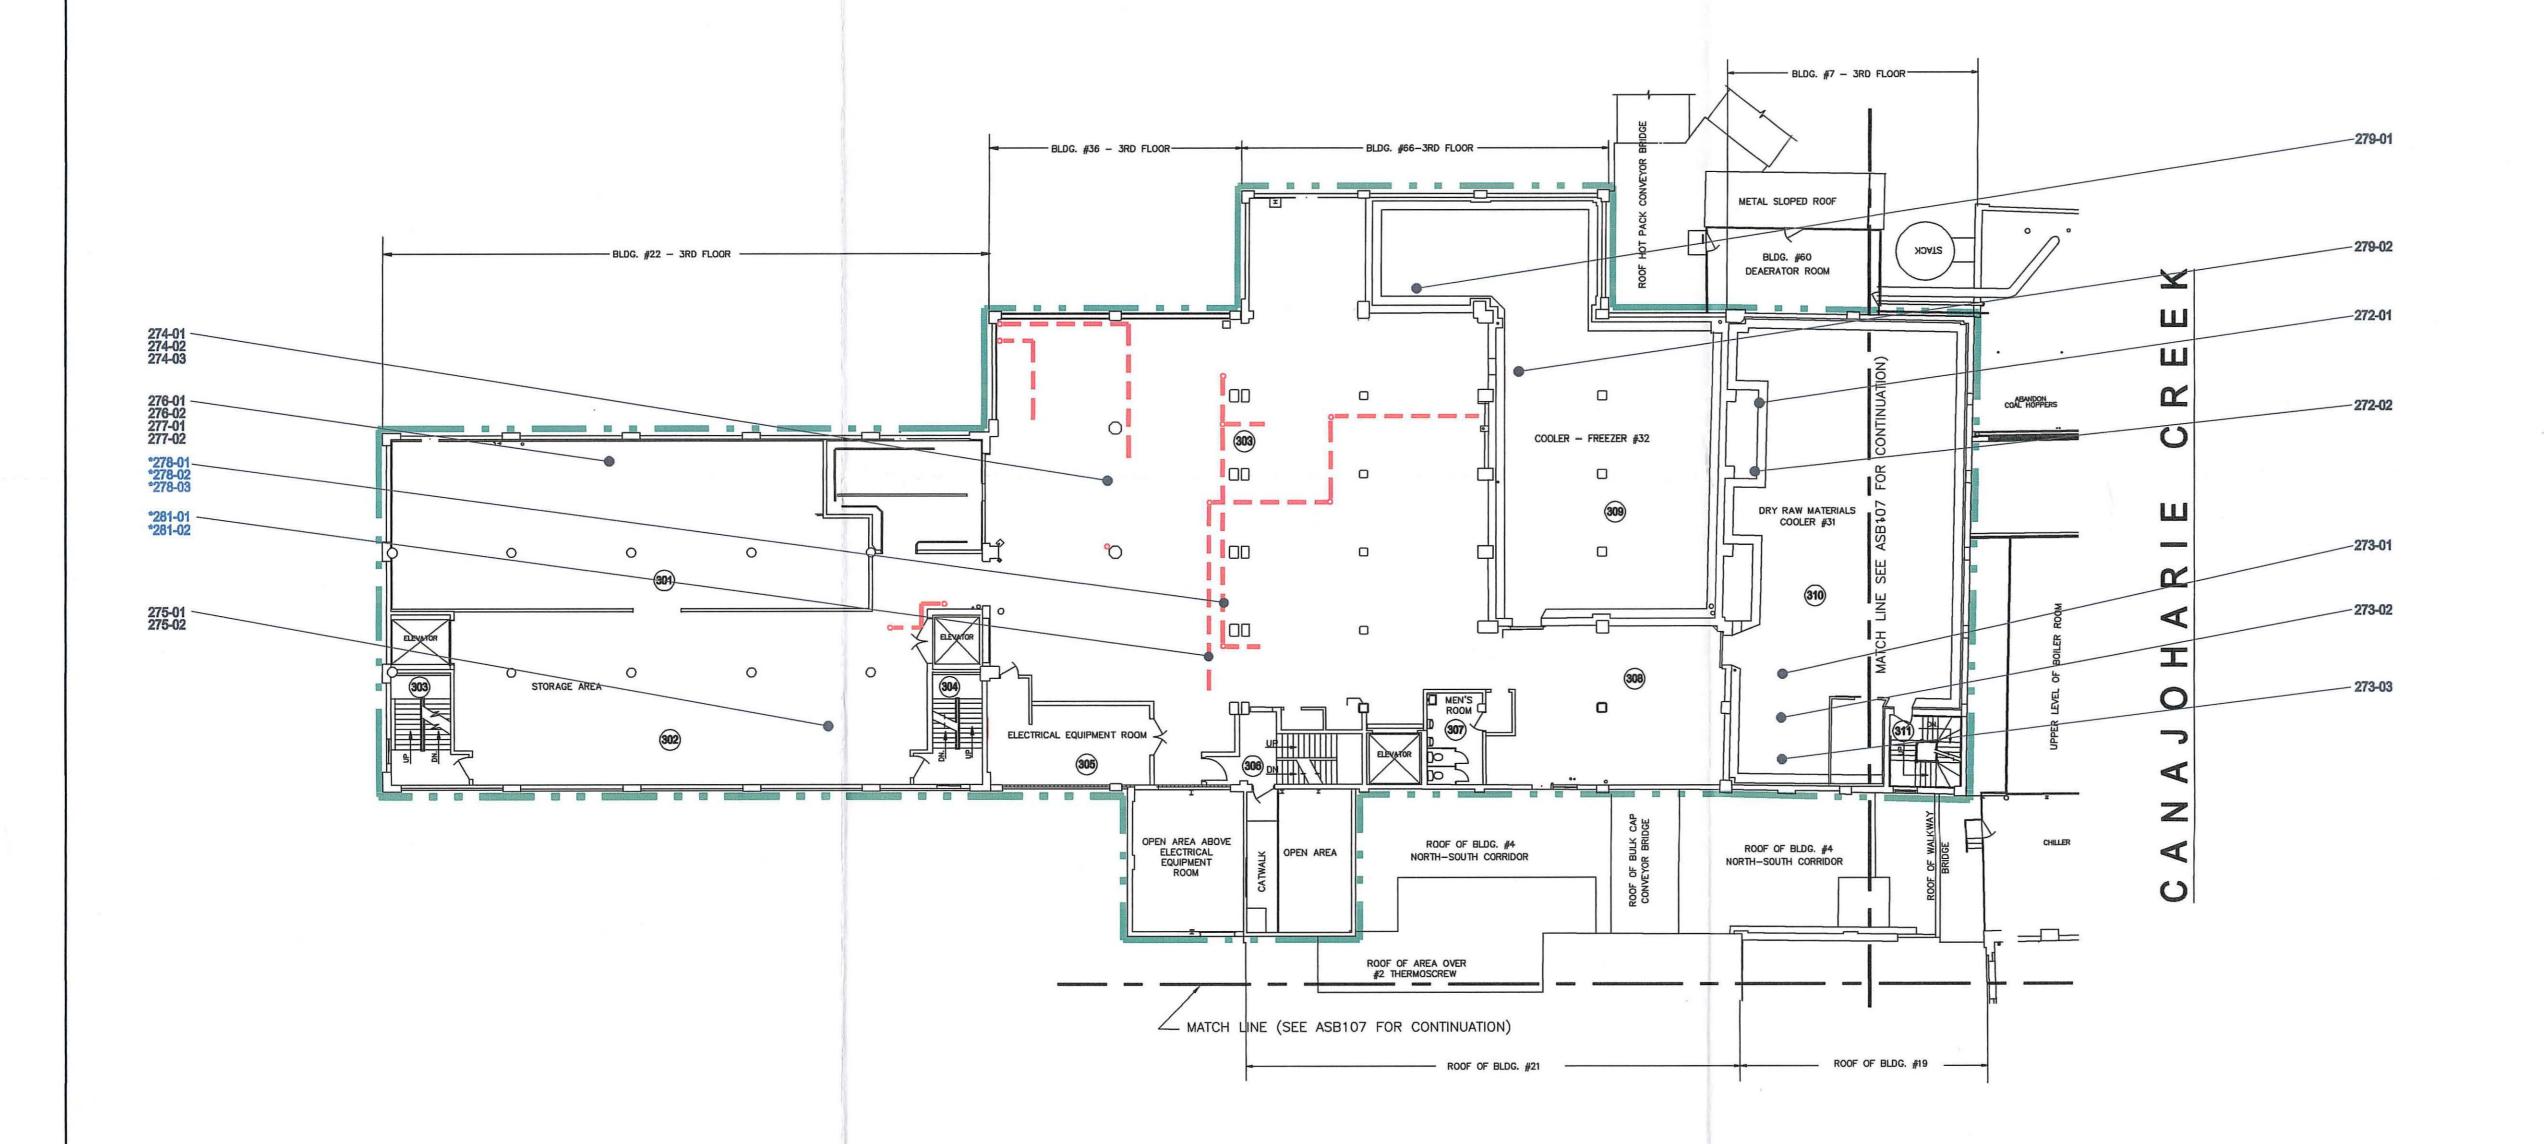
THIRD FLOOR - STRAINED FOOD BUILDING BUILDINGS - #4, #7, #20, #22, #35, #36, #60 AND #66

QTY. LEGEND XXXXX SAMPLE NUMBER NA SAMPLE LOCATION NUMBER *XXXXX POSITIVE SAMPLE NUMBER SEE NOTE 1 EXTERIOR WHITE PAINT 450 L.F. THERMAL SYSTEM INSULATION LARGE AND SMALL DIAMETER 15 EACH THE QUANTITIES LISTED ABOVE ARE ESTIMATES OF THE ASBESTOS CONTAINING MATERIALS PRESENT IN THE AREAS ON THIS DRAWING.

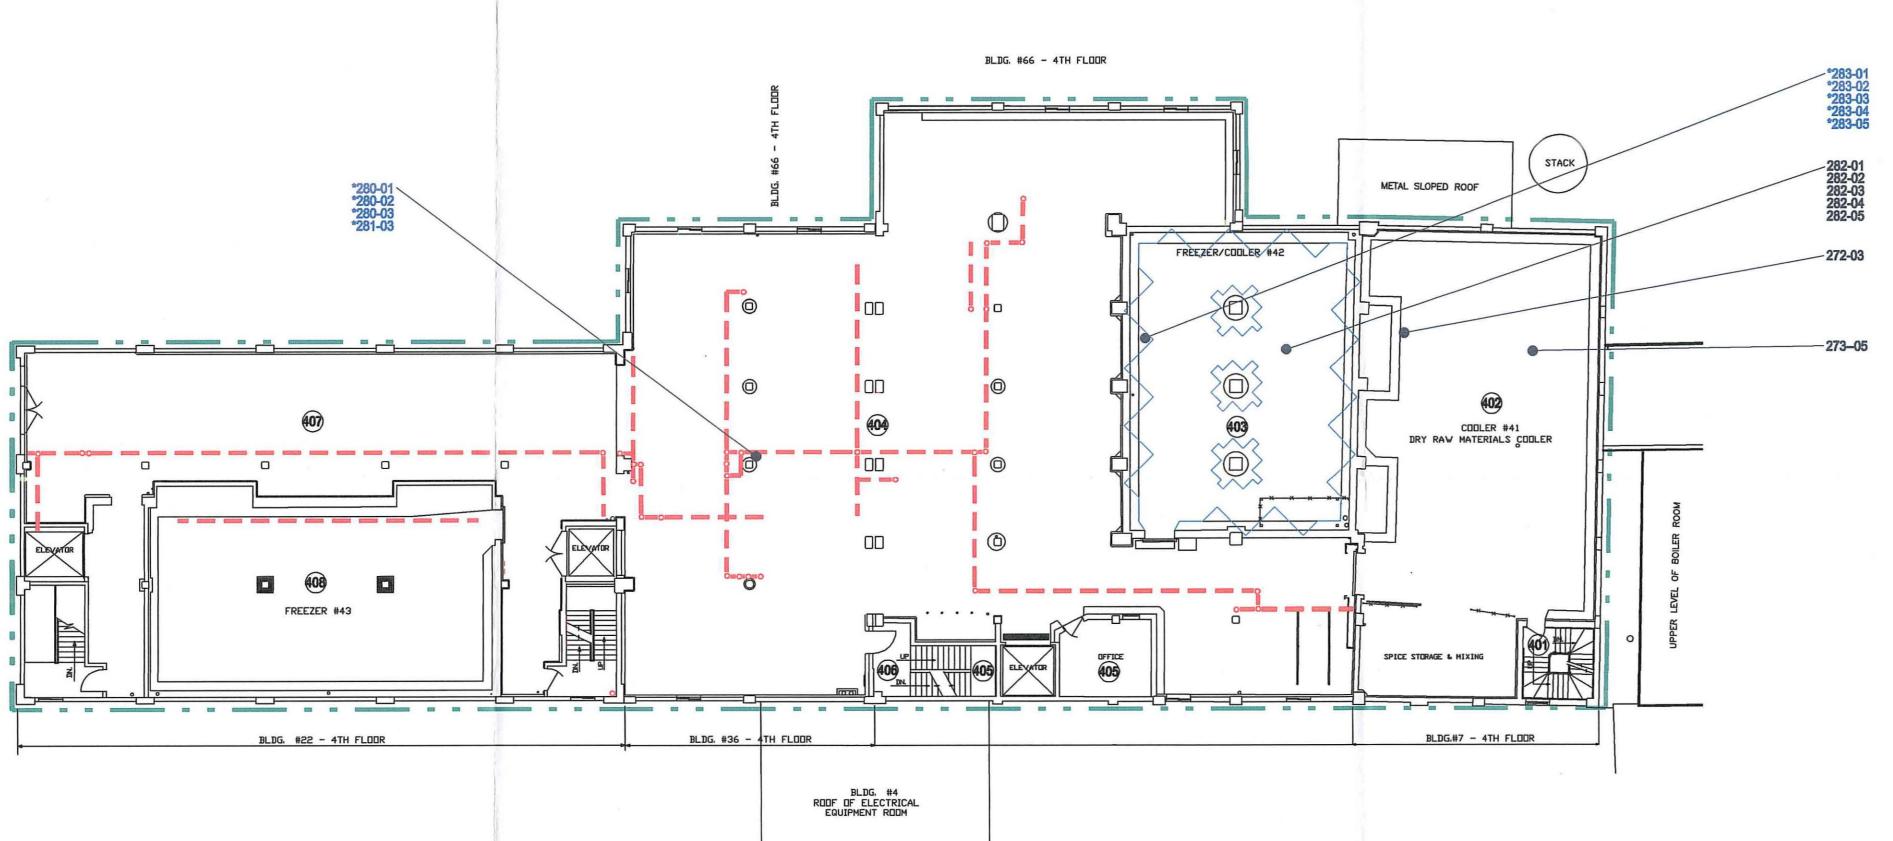
FOURTH FLOOR - STRAINED FOOD BUILDING BUILDINGS - #7, #20, #22, #35, #36, #60 AND #66

1	LEGEND	QTY.
XXXXX	SAMPLE NUMBER	N/A
	SAMPLE LOCATION NUMBER	N/A
*XXXXXX	POSITIVE SAMPLE NUMBER	N/A
	EXTERIOR WHITE PAINT	SEE NOTE
	THERMAL SYSTEM INSULATION LARGE AND SMALL DIAMETER	420 L.F
0	PIPE FITTINGS	42 EACH
~~~	INTERIOR SILVER PAINT	3,390 S.F

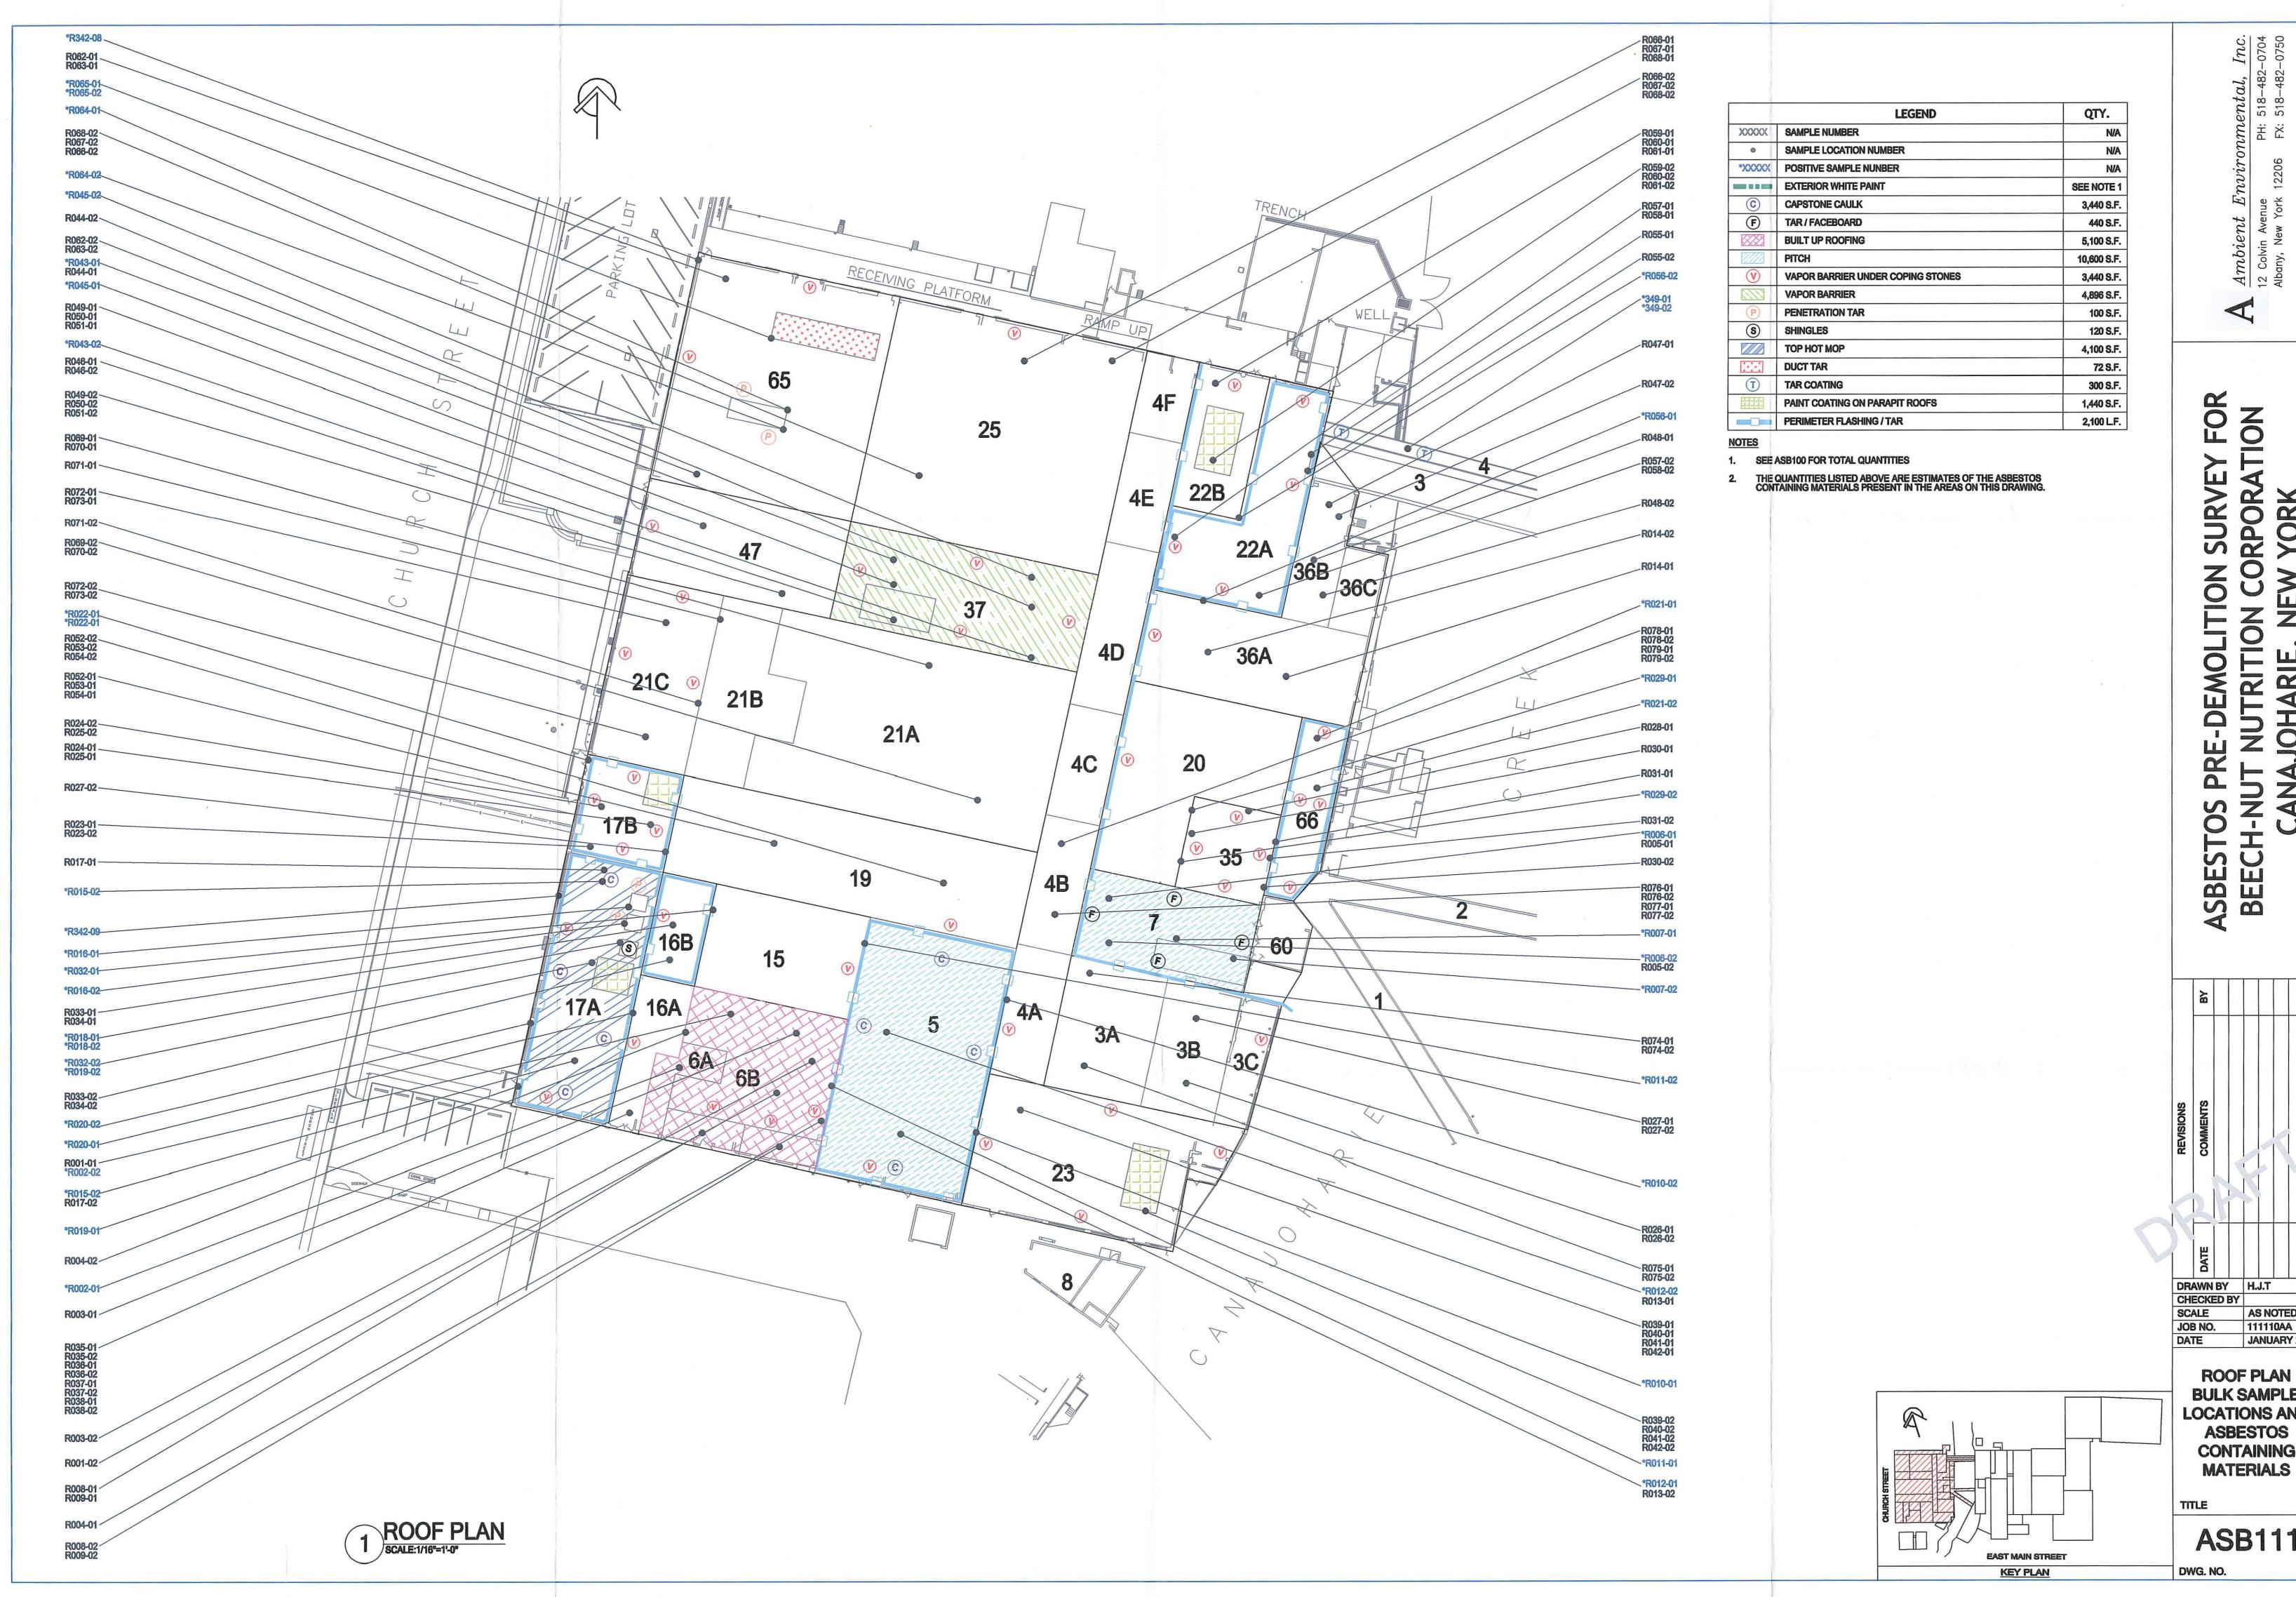
ASB 111 ROOF PLAN

TABLE 3 LEGEND	QTY.
	ROOF	
	PERIMETER FLASHING / TAR	
C	CAPSTONE CAULK	
F	TAR / FACEBOARD	
	BUILT UP ROOFING	
04/2	PITCH	
V	VAPOR BARRIER UNDER COPING STONES	QUANTITIES
1111	VAPOR BARRIER	LISTED ON ASB111
P	PENETRATION TAR	
S	SHINGLES	
	TOP HOT MOP	
++++	DUCT TAR	
T	TAR COATING	
	PAINT COATING ON PARAPIT ROOFS

THE EXTERIOR COATING HAS BEEN FOUND UNDER CAP STONES, ALUMINUM PARAPET WALL CAPS, AND IN OTHER CONCEALED SPACES. THIS MATERIAL IS IN NON-FRIABLE CONDITION ON MUCH OF THE STRUCTURE BUT IS DAMAGED AND FRIABLE IN OTHER AREAS SUCH AS AT ROOF LEVEL WHERE EXTENSIVE WEATHERING HAS OCCURRED. THIS MATERIAL MAY EXIST
